**DRAFT**

10-7-14

Re: 2008 Nissan Altima S #1N4AL21E38N450036, Giancardo Guidoi

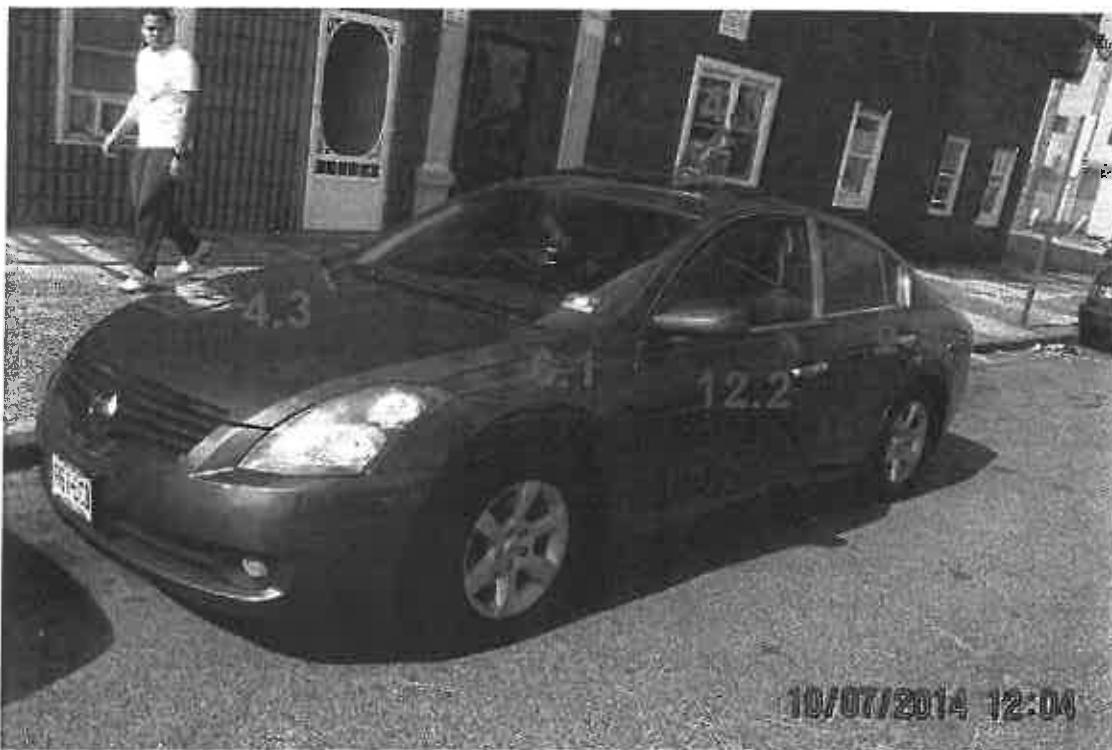
**The left side body panels paint film thickness is shown in the above image. One will note the inconsistency in the readings based on the fact there were body repairs and repainting on the left front door and quarter panel. One will note the inconsistency of the readings, an obvious indicator to a dealer conducting a pre-sale inspection for a vehicle being retailed to the public. There is an issue of durability of non-factory finishes as they have over the years been prone to failures due to inconsistency in technician training, facilities and equipment**

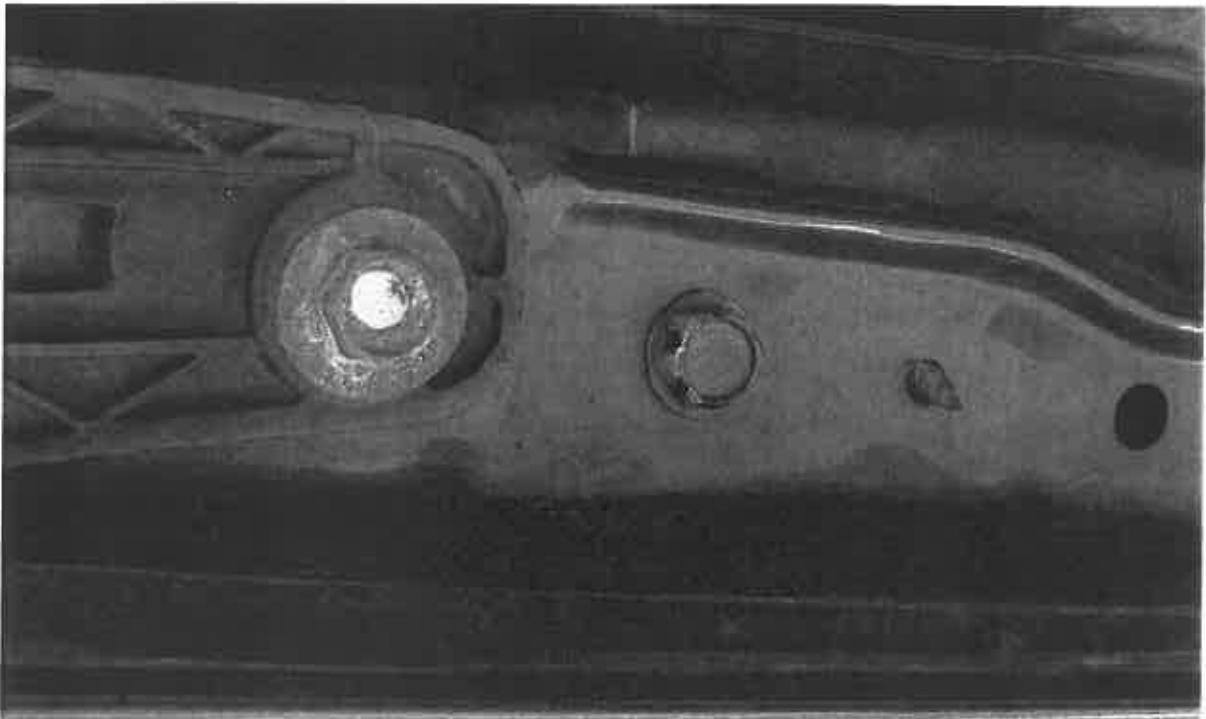
*The above photo shows the left fender forward bolt with the distinctive tool marks of collision damage and repairs. Anyone in the industry would have seen this and a conscientious dealer would have investigated further.*

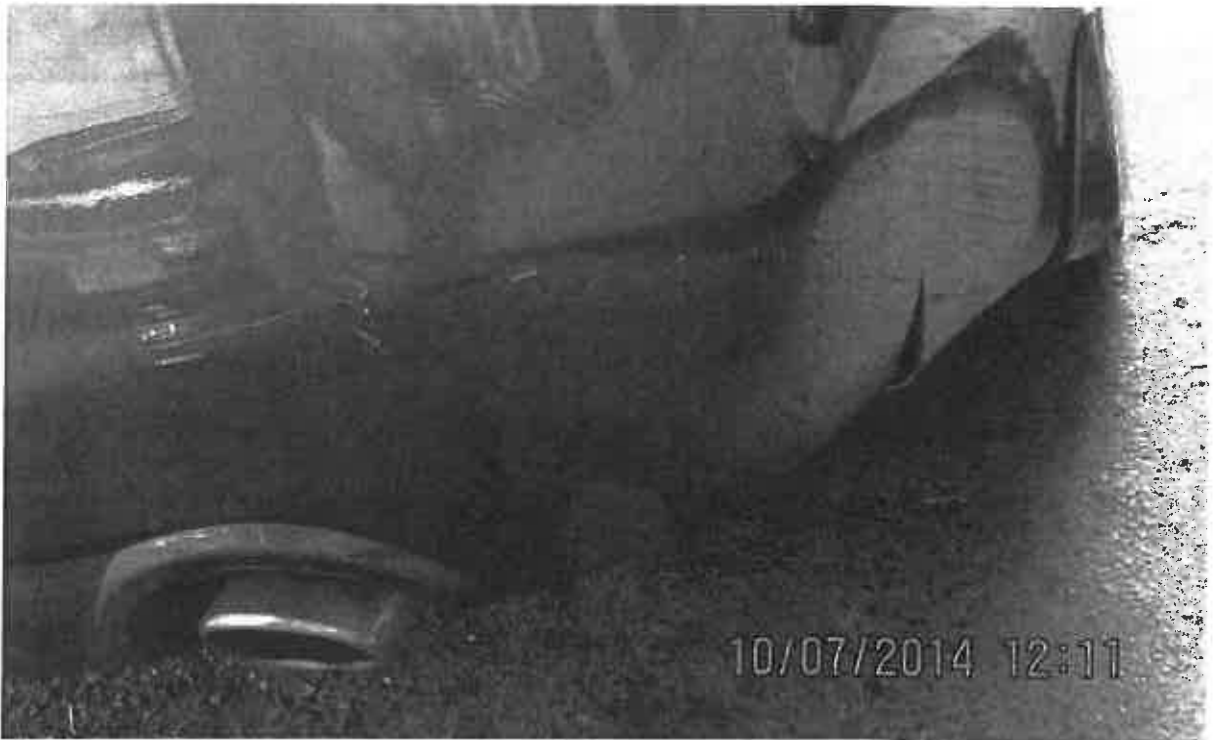
*The above photo shows some unrelated damage to the rear bumper cover on the right side.*
